BYE'S HOUSE, GREAT LAKE Historic Heritage Plan of Management

Final Report prepared for
Hydro Tasmania Consulting

20 December 2010

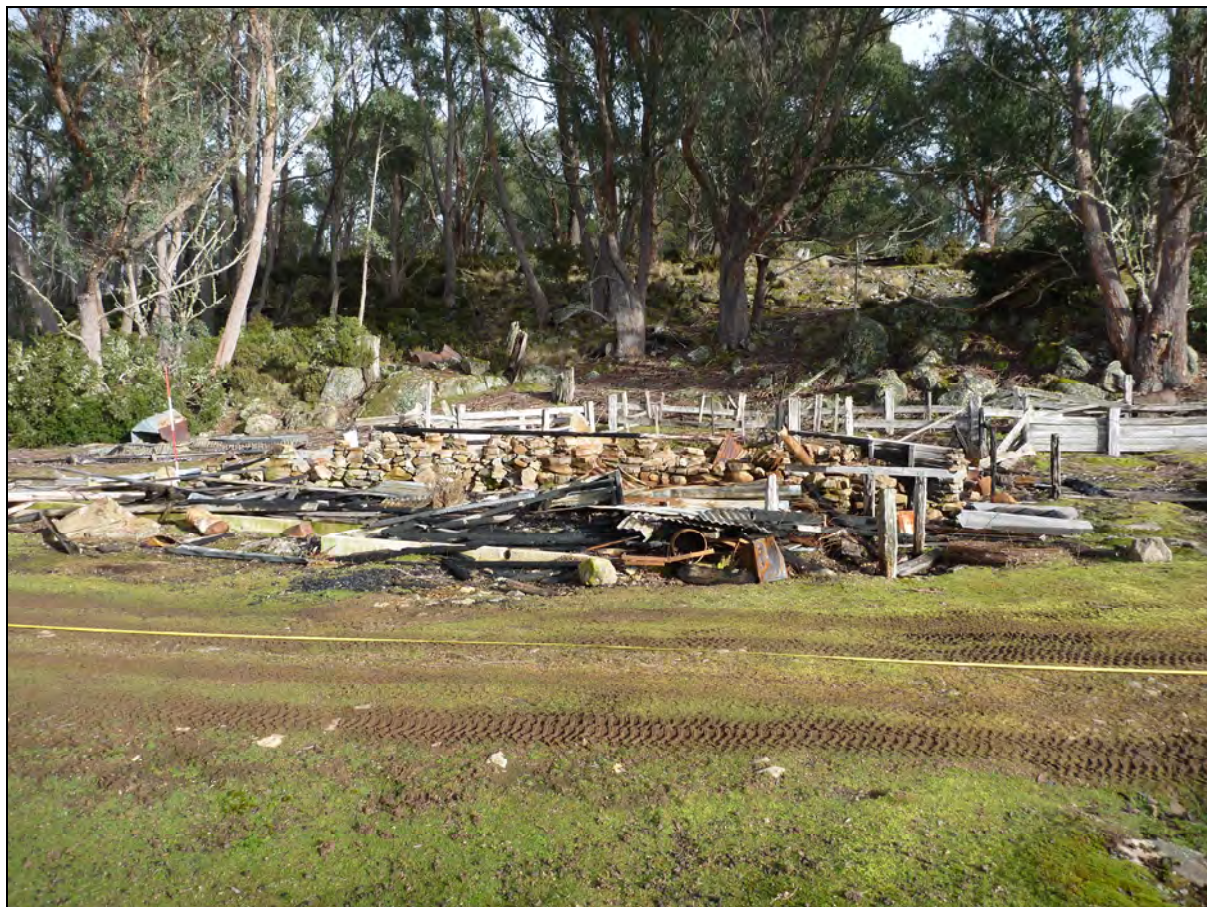
South of the house is the location of the garage/stable/shearing shed complex. The complex has been destroyed by fire and ruinous structural elements remain. The garage was located on the south eastern corner of the complex, with an entranceway of c.3.55m wide and a length of c.5.4m. The coarse concrete aggregate foundations of the garage are c.15mm wide and up to c.30cm in height above the ground level. At the northern end of the garage is the location of the stable block, which contained two stalls, with a coarse aggregate concrete floor. The stable has dimensions of c.3.8m x c.4.5m (photo 5).

Photo 5: Garage/stable/shearing shed complex, looking from the east.

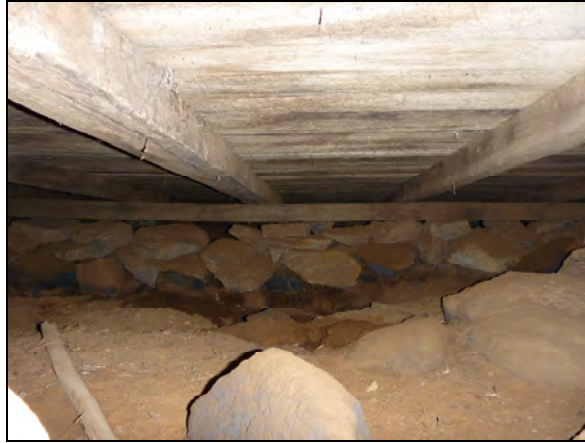
Main building: The bottom plate of the main building is set on a 400mm - 500mm high, contiguous stone rubble foundation. There are no piers supporting the sub-floor structure. Instead, the bottom plate of the building is carried on a contiguous dry stone foundation that runs around the perimeter, the floor bearers spanning the 5 metre gap between the side walls. The west wall foundation has assumed a minor retaining wall function, as this is the point at which the structure is cut into the hillside. There are parts of the foundation that appear to have been pivotal in the establishment of the structure by functioning as stacked stone piers with the intervening spaces subsequently filled and wedged with rubble up to the underside of the bottom plate.

The underfloor space is open and clean, the height of the foundations providing between 300mm and 500mm of clearance between the timber substructure and the ground surface. It is also, for the most part dry, with the exception of the ground at the base of the west wall foundation, which appeared damp in patches. This is probably due to the failure of the overhead guttering and the fact that the west wall foundation represents the point at which the structure intercepts and absorbs any flow of water down slope. The section of underfloor substructure able to be inspected through a gap in the stonework appeared to be in excellent condition, no doubt aided by the raised foundations, which promote airflow (photo 12).

Photo 12: Underfloor structure.

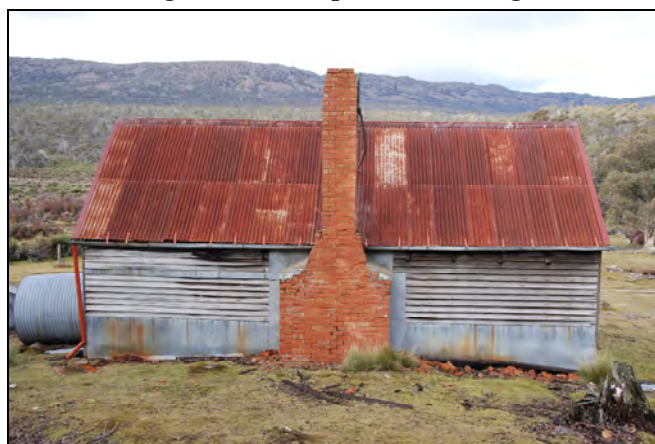
The west wall is comprised of a combination of both weatherboards and iron, with a strip of flat iron cut and inserted in place of absent weatherboards. Flat sheet has also been used to clad the space around the chimneybreast and from ground level upwards to a height of 850mm (photo 16).

Photo 16: western wall with combination materials.

The latter is clearly a response to water damage, most likely from rusted out guttering evident at the edge of the western side roofline. It is likely that the flat sheets have been used to cover deteriorated or missing sections of the weatherboard walls. The detail on the branded sheets coupled with reference to the site history and Figure 8 suggests that the flat sheet was introduced to the structure sometime after 1960 and before 1971 and therefore, has formed an integral part of the structure for a period between 40 and 50 years.

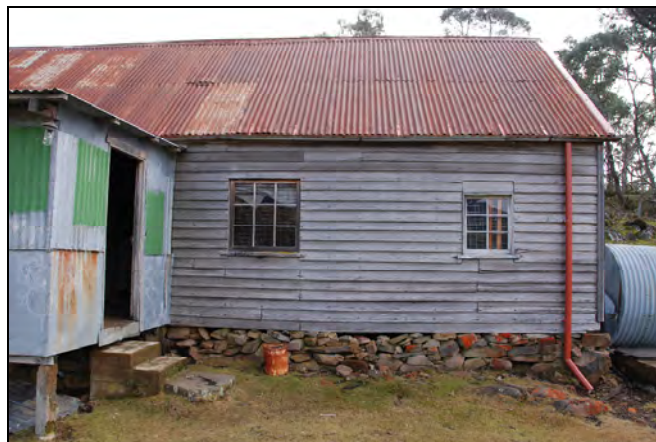
The building has a gabled roof clad in rusted corrugated iron (short) sheets fixed predominantly with red painted tek screws (replacing lead washer roofing nails) (photo 17).

Photo 17: Roofing material.

- Diluted Fishoilene™ may be applied to extend the lifespan of the comprehensively rusted roof of the house.

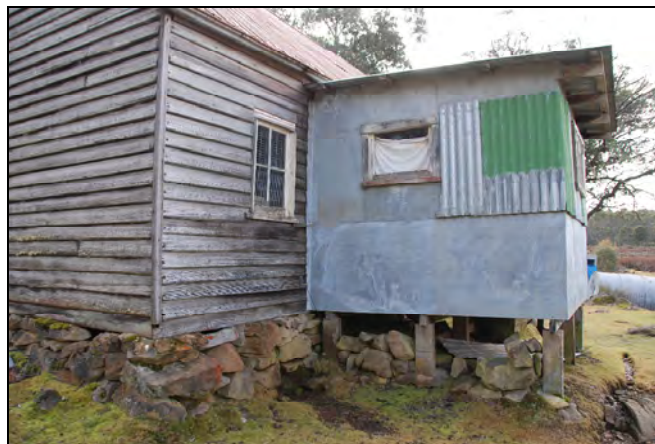
window in the south wall has replaced the array of windows depicted in Figure 8. The resulting voids have been patched with corrugated galvanised iron that overlaps the original flat iron sheeting (photo 20). The light fitting depicted in Figure 8 remains in place, fixed to a rafter forming part of the eaves at the north-eastern corner of the porch. The porch door has been strengthened in recent years through the addition of powder coated metal bars and a chain and padlock arrangement added in an attempt to prevent unauthorised access to the interior.

Photo 20: corrugated iron patching.

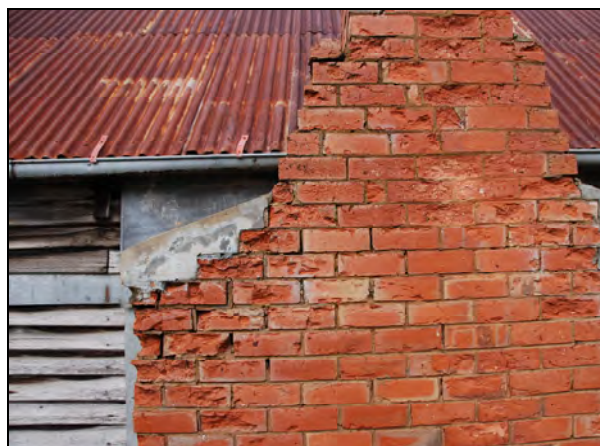
The house chimney is comprised of machine-made orange clay bricks (photo 21). The chimney breast is 2 metres wide x 800mm deep x 1.85m high and tapers giving rise to a chimney that is 3m in height. The tapered section was repaired in 2004 (as evidenced by the inscription ‘SKIP 04 T.W.F’ in the cement render). The bricks show evidence of spalling and in places mortar is missing, both a likely consequence of the freeze-thaw effect that is prevalent in the Central Highlands climate (photo 22).⁵⁷

Photo 22: 2004 cement repairs and missing mortar.

- Re-point the chimney using a mortar mix appropriate to the deteriorated condition of the brickwork.

- Install a spark arrestor in the chimney to minimise the prospect of burning embers starting a bushfire.

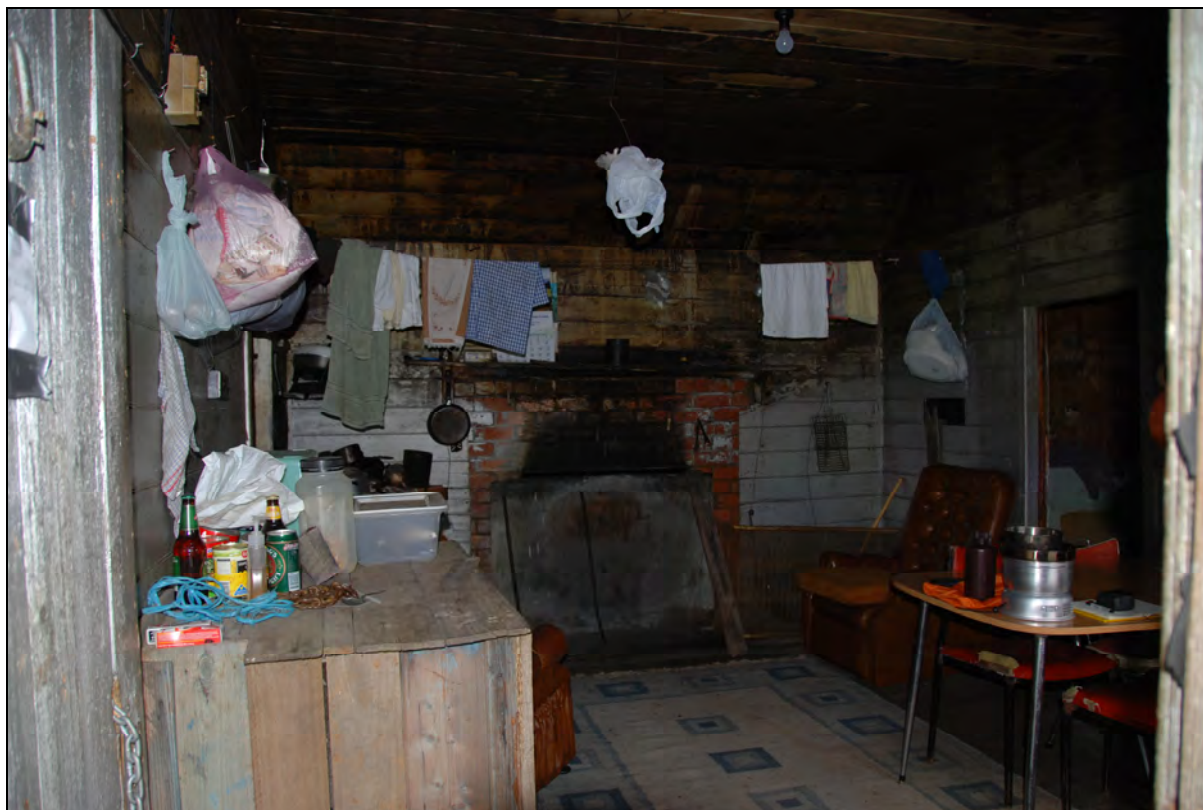
Photo 30: Central living space and fireplace, looking from entrance porch. Note soot residue on west wall and ceiling.
