BYE'S HOUSE, GREAT LAKE Historic Heritage Plan of Management

Final Report prepared for
Hydro Tasmania Consulting

20 December 2010

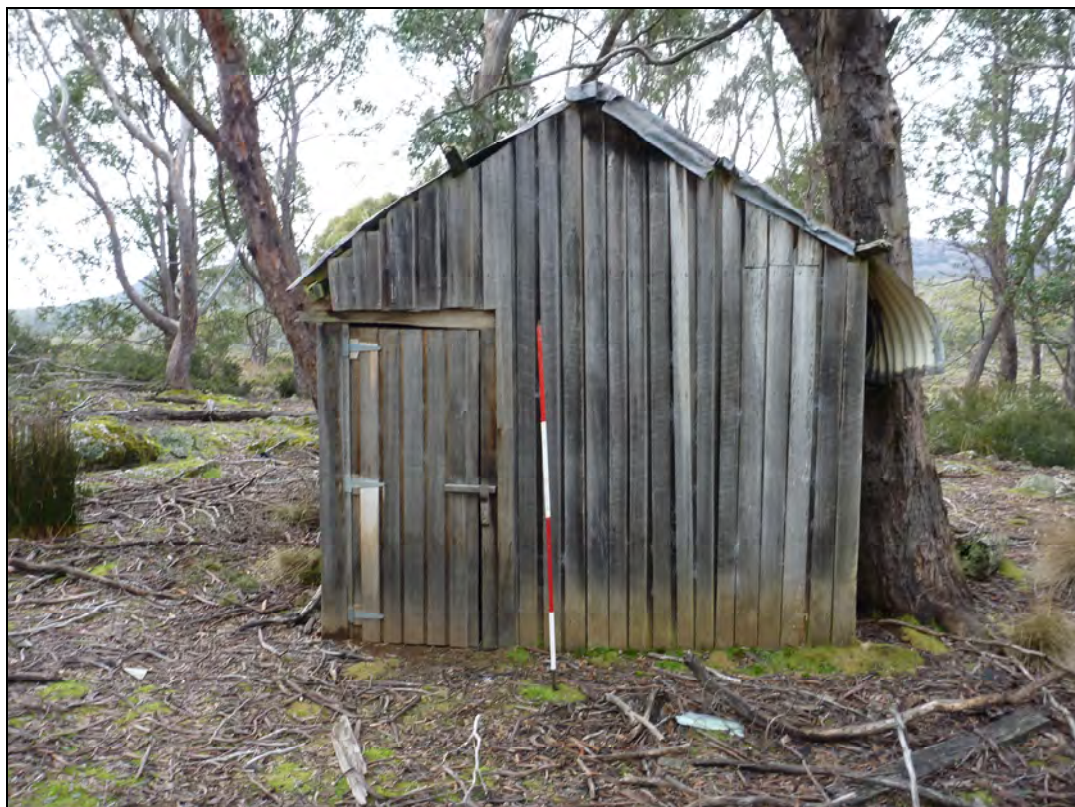
Photo 1: Western elevation of the hay shed with entrance door.

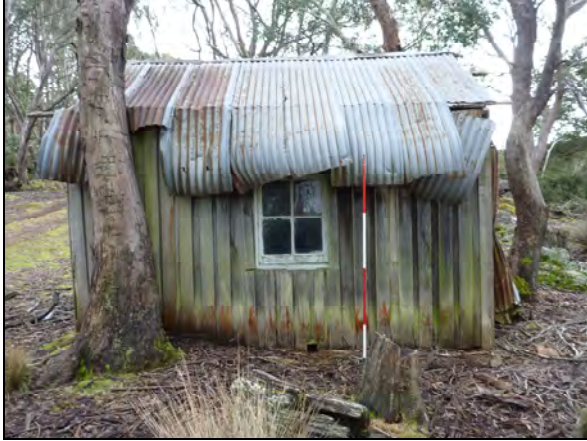
Photo 2: Southern elevation of hay shed, with single window and any overhanging sheets of corrugated iron.

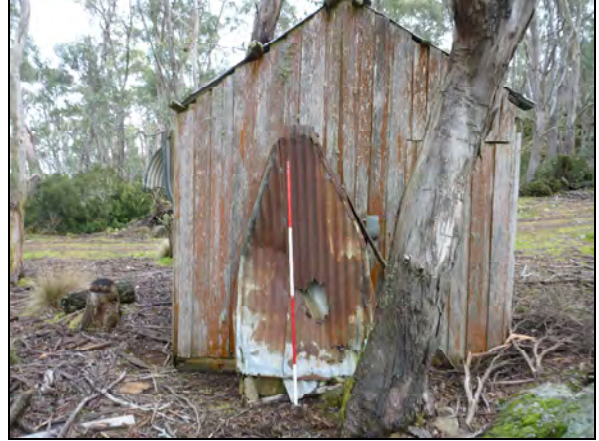
On approach to the house, and at a point just before the entry gate, the track passes a hay shed to its east (Photo 1). The shed is a relocated ex Hydro structure, reportedly salvaged and set in place by Alfred Bye.⁵⁴ The hay shed is orientated east to west and is a timber framed vertical board building of 3.15m x 4.2m (approx). It has a gabled roof clad in corrugated iron, with the ridgeline approximately 3.5m above ground level. The roof appears to have been replaced at some stage, as the corrugated iron on the southern plane exhibits a substantial overhang and has not been cut to meet the eaves (photo 2). The shed originally had entrance doors on the eastern and western elevations, however the eastern elevation has been closed off. A simple, four paned window is centred on the southern elevation, and a corrugated iron chimney, redundant and in poor condition, is located at the eastern end of the structure (photo 3).

Photo 3: Eastern elevation of hay shed, with chimney base, and blocked off second entrance.

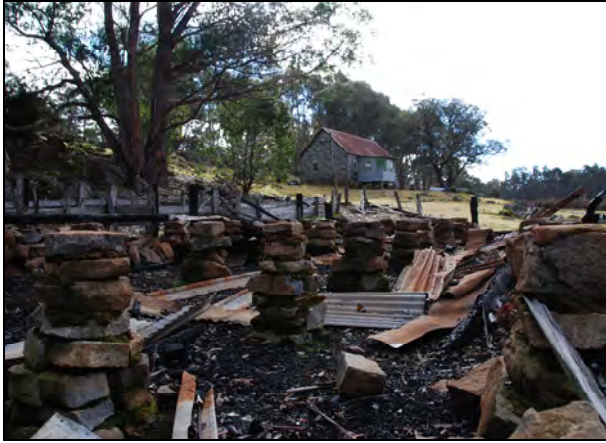
Photo 6: Stone piers of the shearing shed.

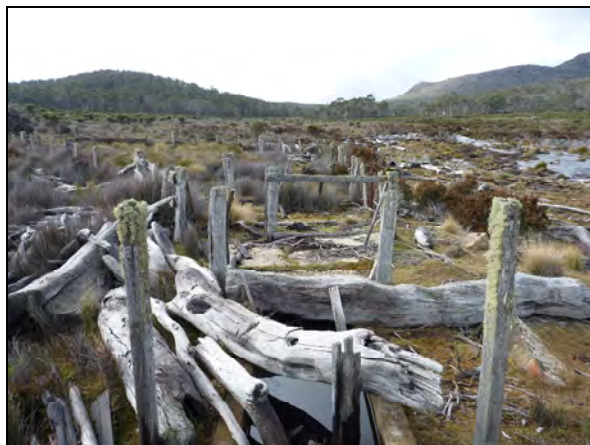
Photo 9: Concrete lined dip.

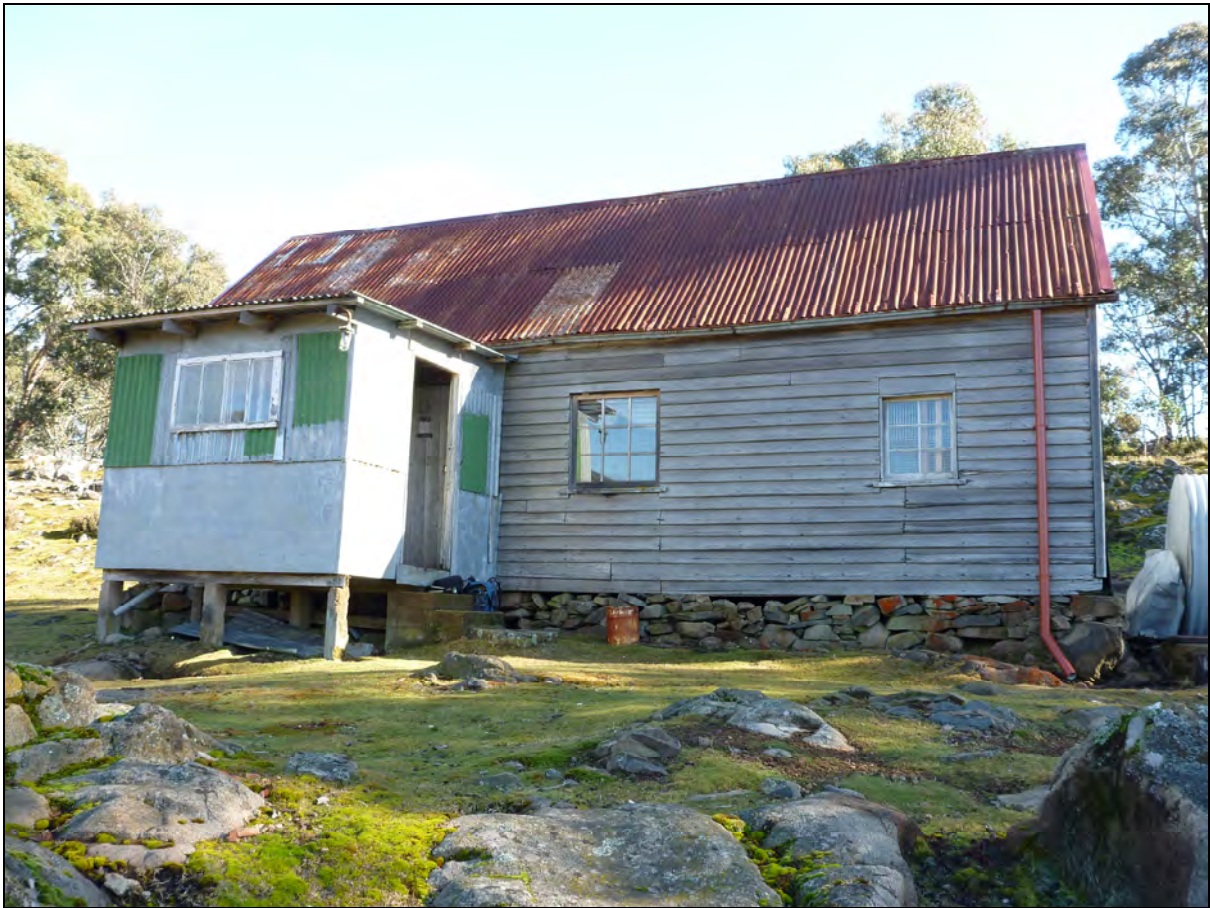
Photo 11: Eastern facade of Bye's House.

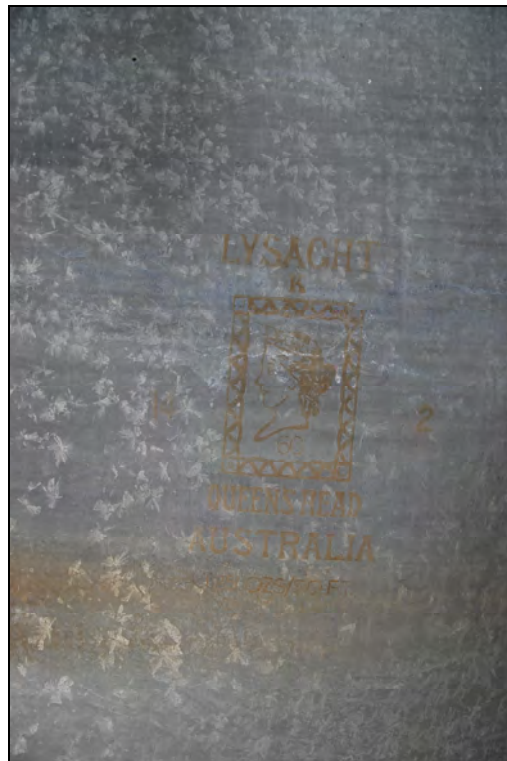
The walls of the main building consist of a combination of the original unpainted bull nosed hardwood weatherboards and flat sheet galvanised iron. The original fixings for the boards appear to be wire drawn rose head nails. The flat sheet is stamped in one or two locations with Lysaght's distinctive "Queens Head" brand. The letters J, L, L, A located at the four corners of the ornate border around the queen's head stand for John Lysaght Australia Limited (indicating the product was made locally as opposed to overseas). The 'K' below the manufacturers name possibly indicating that it was produced at the company's rolling mill and galvanising plant at Port Kembla south of Wollongong. The figure '60' on the neck denotes that the sheets were manufactured in 1960 (photo 13).

Photo 13: Detail of Lysaght sheeting.

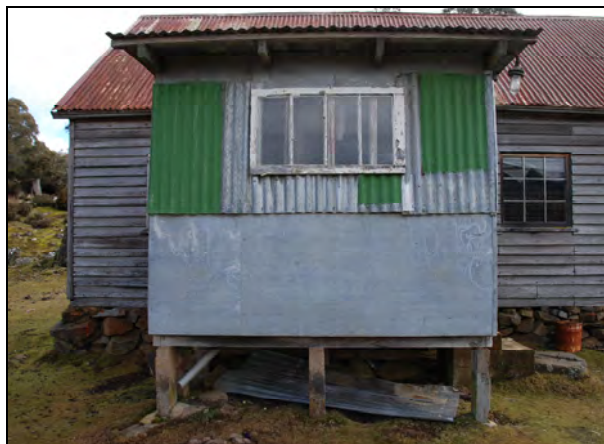
Porch addition: Entry to the main building is via a 2.6m x 2.2m skillion roofed porch that has been added to the eastern side wall (photo 18). This serves as a wood store and as an all weather transitional space between the exterior and the living spaces of the main structure. This structure is independently supported on eight square profile concrete piers and, in part, on concrete steps related to the entry point located on the northern side (photo 19).

Photo 18: Porch, from east.

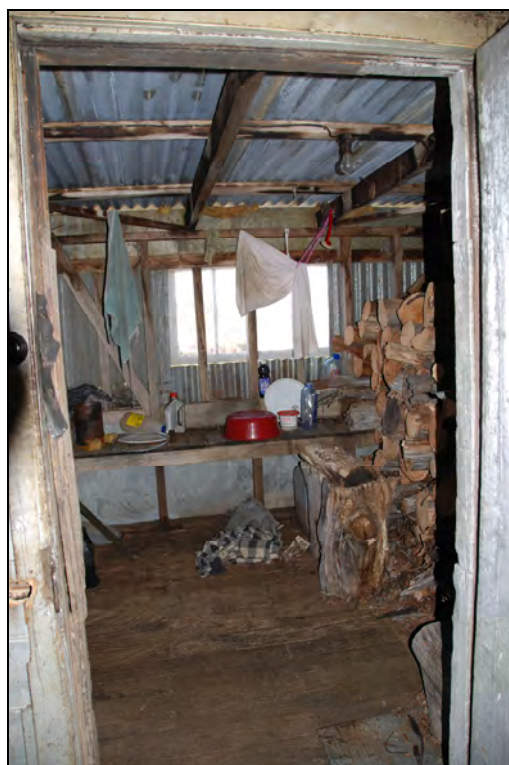
to wash.⁵⁸ The interior of the porch is floored in 110mm wide timber boards. The walls are unlined. It is presently used as a wood store (photo 23).

Photo 23: interior of porch, looking from central living space.

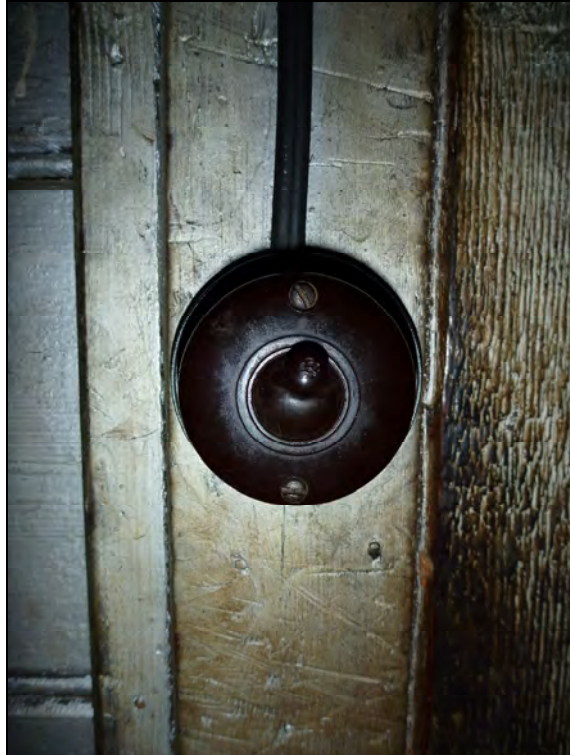
The interior of the main building is divided into five spaces, consisting of a central multifunctional, living, dining and cooking space flanked by two bedrooms on either side. The majority of exposed wall linings and that of the tent ceiling consist of tongue and groove beaded profile deal (softwood) boards. In exposed sections the linings have an orangey-red hue suggestive of past treatment. The colouring is consistent with the application of shellac although this is not firmly established within the context of this report. Silver paint has been applied to the walls in the main living space and all walls with the exception of those in the south-west room have been covered in paper (see below for further description). Floors throughout the main structure are comprised of tongue and groove hardwood boards 100mm in width.⁵⁹ Bakelite electrical fittings (currently redundant) are present in places (photo 24).

Photo 24: typical Bakelite electrical fitting.

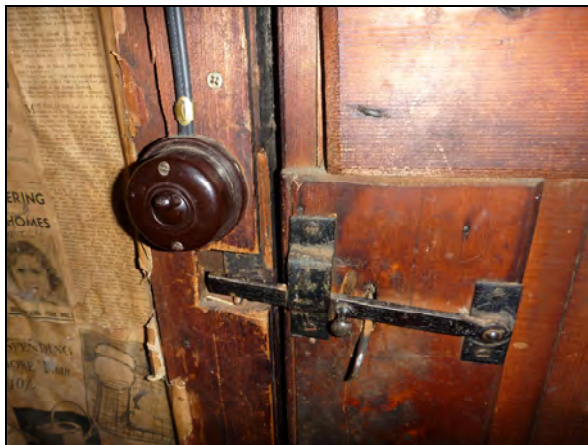
Photo 25: north east room latch, inward side of door.

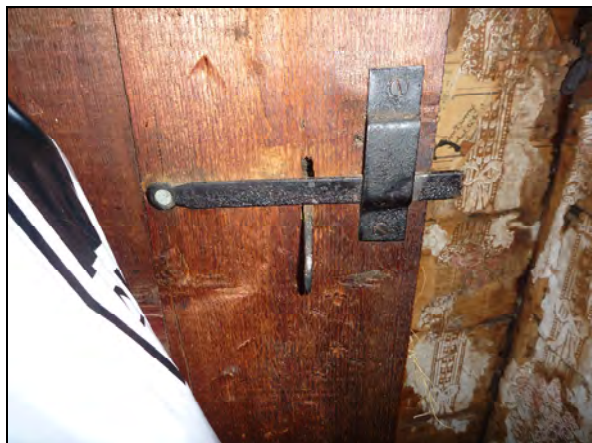
Photo 27: south east room latch, inward side of door.

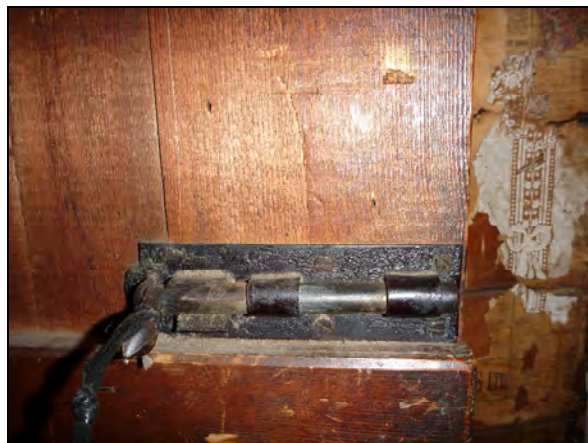
Photo 28: south east room lock, inward side of door.

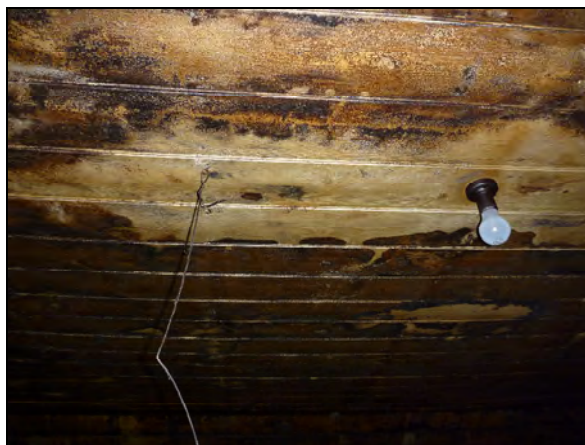
Photo 29: wire from ceiling, reportedly for preparing snares.

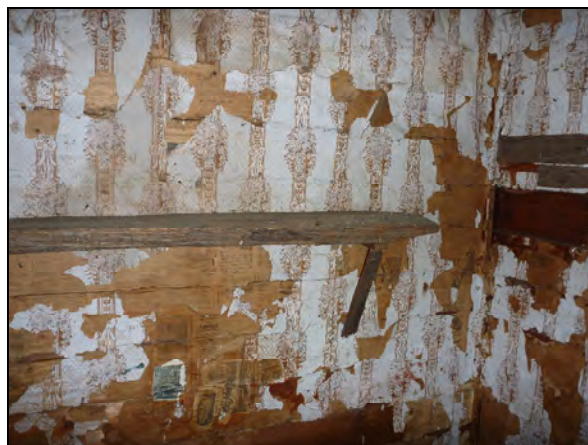
Photo 32: south east room, with bench, newspaper and wallpaper remnants.

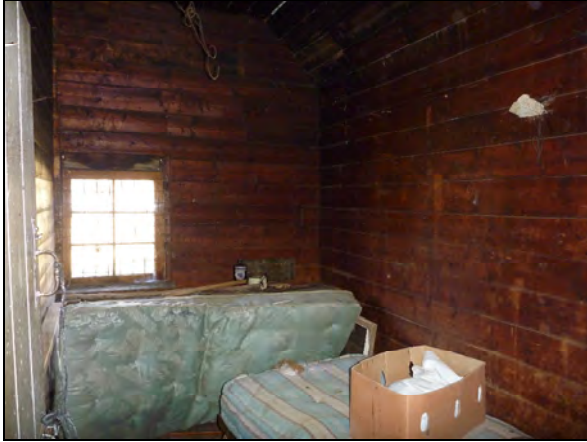
South-west room (photo 37): Measuring 3m x 1.9m this is the smallest of the four rooms flanking the central living area. It is also the only space in which the walls have not been covered. One section of beaded wall lining has been replaced with rough sawn boards. A slab shelf runs the width of the room above the doorway and a bench is located under the window (photo 38). It has been used as a bedroom but judging by the lack of wall coverings and the utilitarian nature of the shelving, this may not always have been the case.

Photo 37: south west room, looking south with bed, window and bench beneath window.

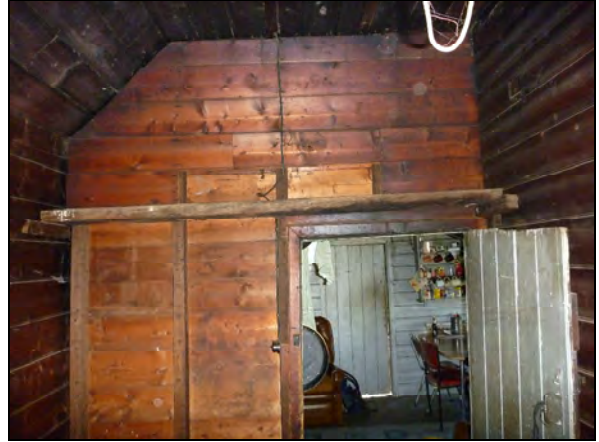
Photo 38: south west room looking north with slab bench above door.

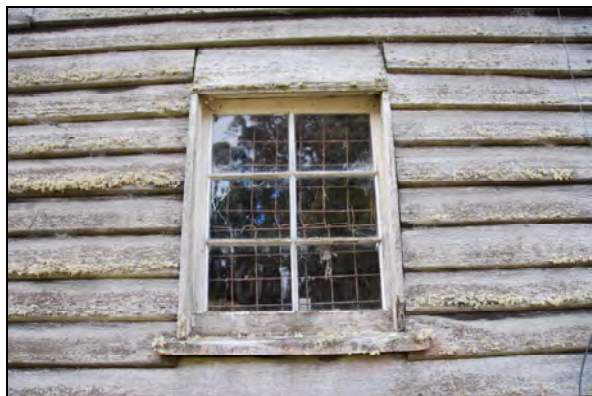
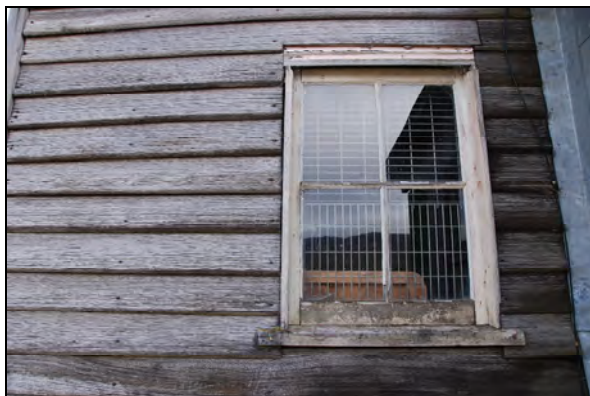
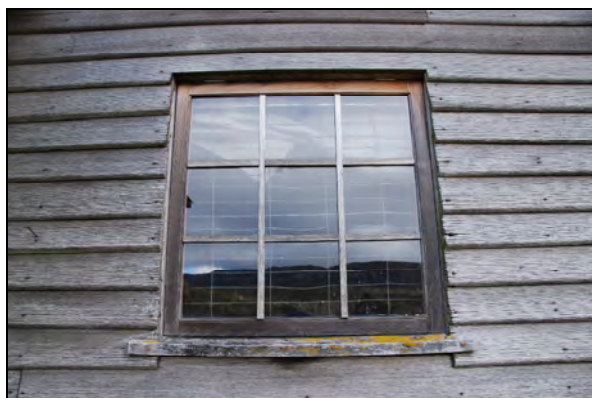
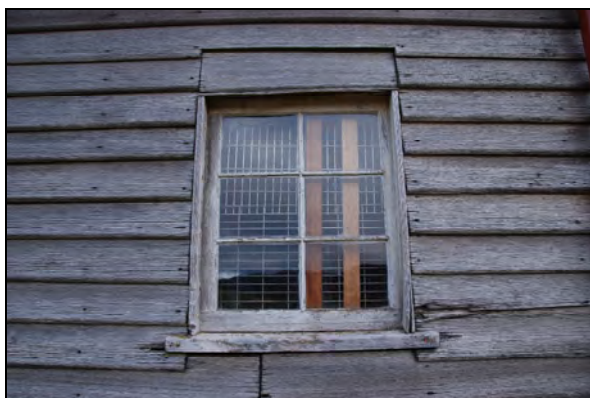
The fenestration in the main building has also been altered over time. Excluding the porch addition, there are five windows; three in the front (or eastern) elevation, one on the western side of the northern end wall, and one on the western side of the south end wall (refer to Appendix 8, photos 55-59 and compare with those depicted in Figure 8). There are no windows in the western elevation. Two of the windows (those in the north wall, and closest to the porch addition in the east wall) are constructed of perspex and employ timber battens, fixed to give the appearance of glazing bars (see photo 57 for example). These represent works implemented by Hydro Tasmania in 2004. The remaining three windows are glass paned timber framed windows, some with visible paint treatments that have been applied prior to installation. In each case the openings surrounding these windows appear to have been modified to suit the dimensions indicating they are not part of the original fabric.

- Patch hole in the sill by either scarfing in a piece of untreated timber ‘like for like’ (matching both profile and material), or cover patch with a small piece of flat metal sheet cut to fit and affixed with nails (pre-drill holes).
- Assess and reinstate missing putty in glazing bars as required.
