BYE'S HOUSE, GREAT LAKE Historic Heritage Plan of Management

Final Report prepared for
Hydro Tasmania Consulting

20 December 2010

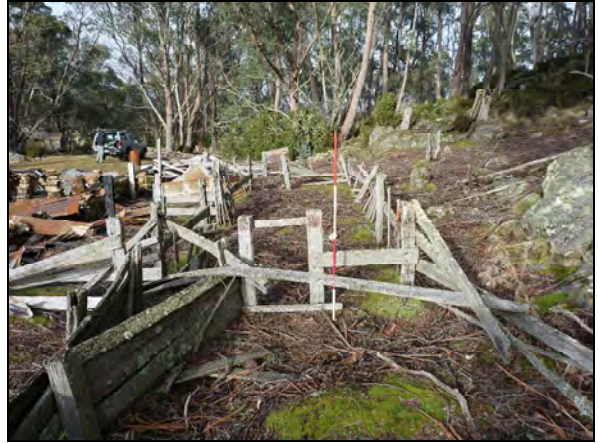
Photo 7: Holding pens and sheep race.

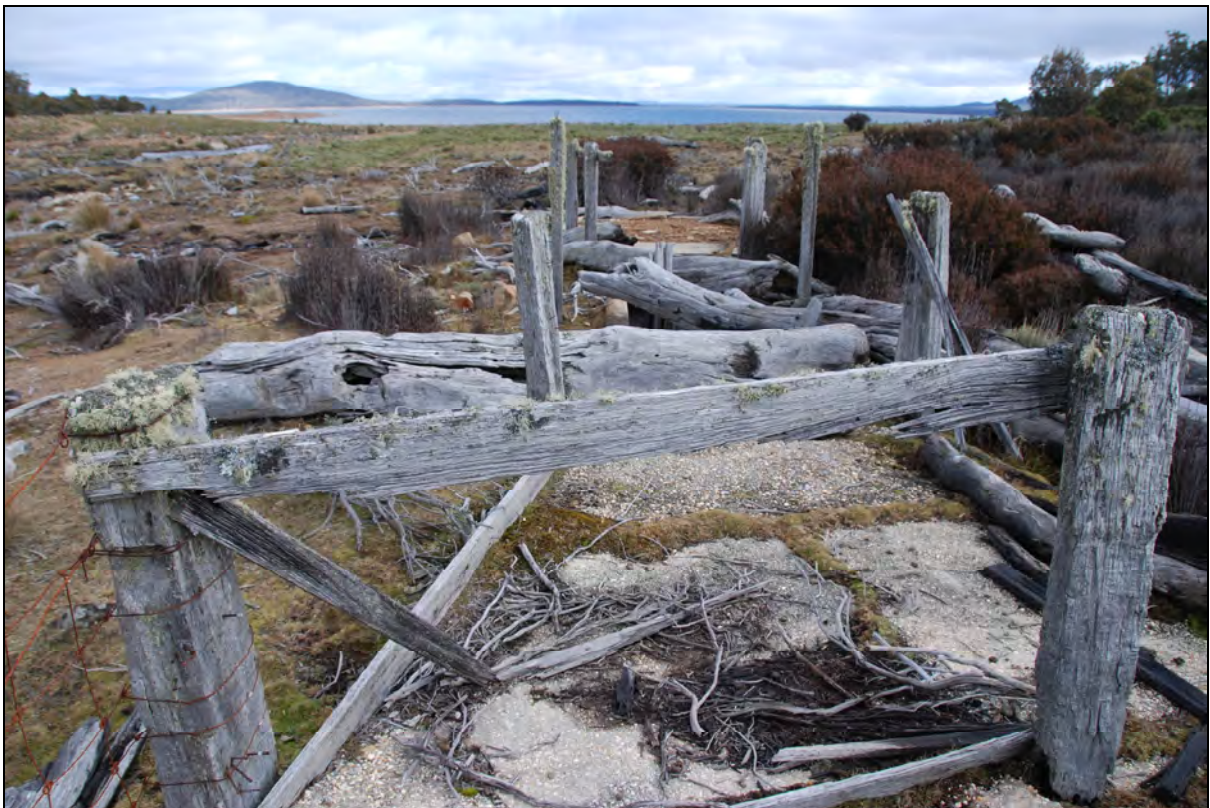
Photo 8: Sheep dip, looking south.

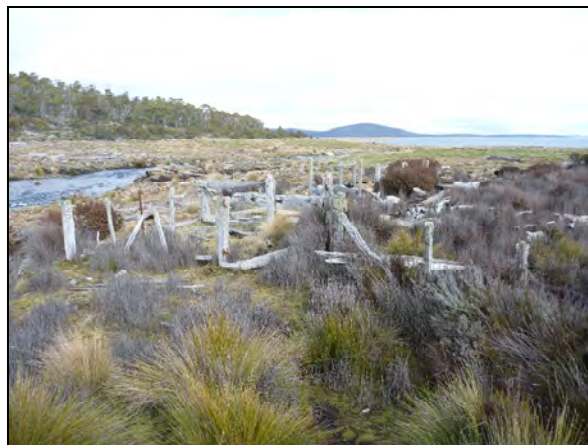
Photo 10: Holding pen at the north.

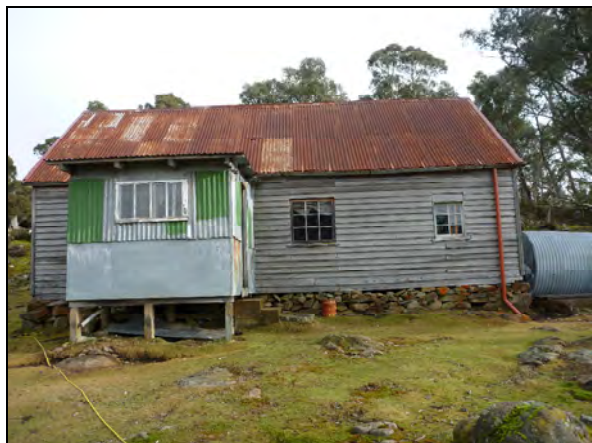
Photo 14: East wall.

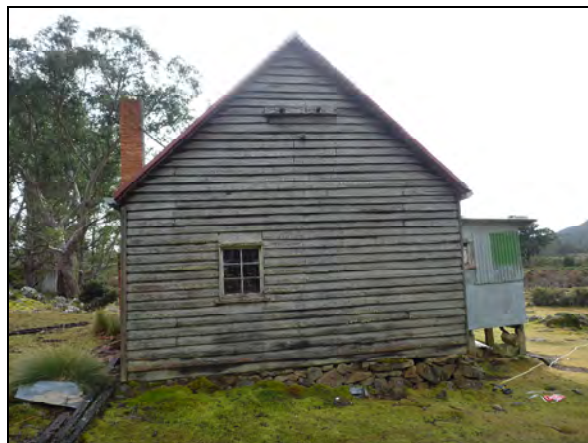
Photo 15: south wall.

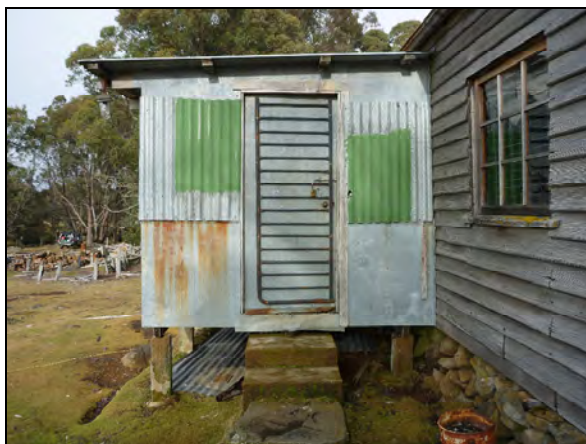
Photo 19: Piers, steps and entrance.

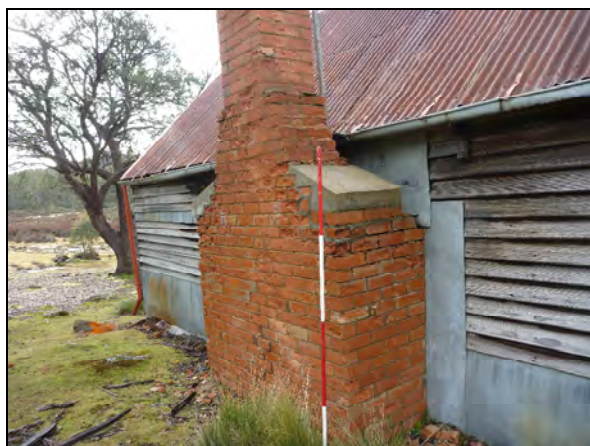
The house chimney is comprised of machine-made orange clay bricks (photo 21). The chimney breast is 2 metres wide x 800mm deep x 1.85m high and tapers giving rise to a chimney that is 3m in height. The tapered section was repaired in 2004 (as evidenced by the inscription ‘SKIP 04 T.W.F’ in the cement render). The bricks show evidence of spalling and in places mortar is missing, both a likely consequence of the freeze-thaw effect that is prevalent in the Central Highlands climate (photo 22).⁵⁷

Photo 21: Chimney.

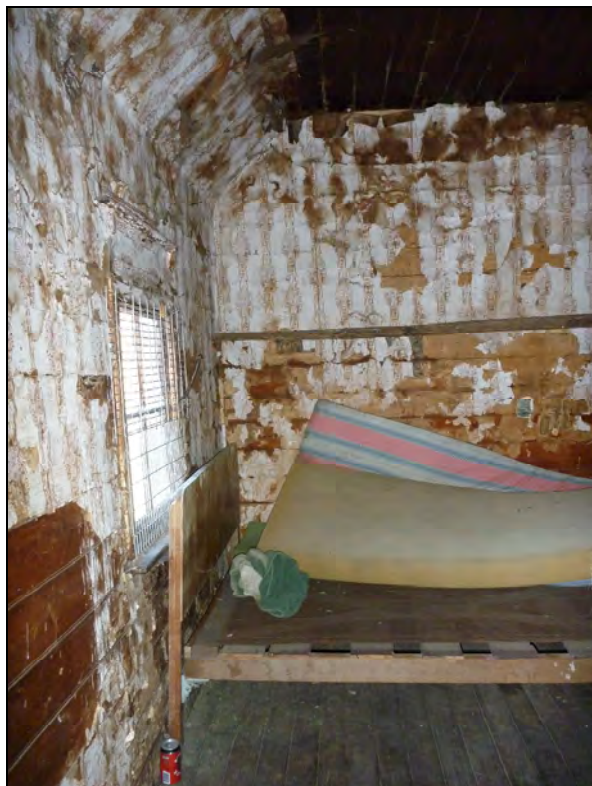
South-east room (photo 31): This is the largest of all the bedrooms measuring 2m x 2.8m. It contains at least two generations of wall coverings with wallpaper overlying sheets of newsprint (photo 32). The latter appears to represent an early application with one sample observed dated Dec 19 1922. The space contains two slat beds (one double, one single).

Photo 31: south east room, looking south with bed, and window.

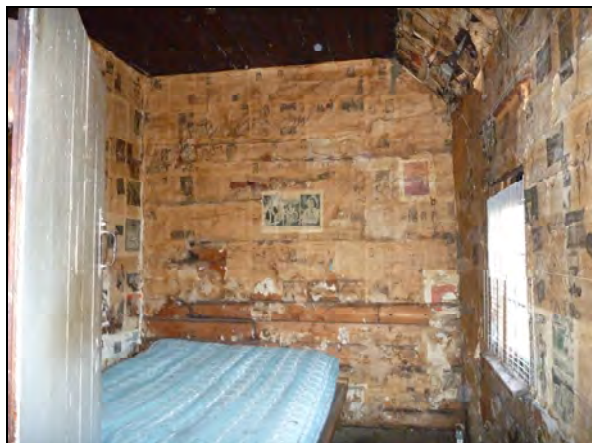
North-east room (photo 33): The second largest of all the bedrooms measuring approximately 3m x 2.5m, this was reportedly Alfred Bye's bedroom throughout his period of occupancy. The walls and the corresponding section of tent ceiling in this space are almost entirely clad in sheets of newsprint and pages from magazines. Ladies fashion is a dominant theme, with wartime reports also noted (photo 34). The publications *Sketch* and *ABC Weekly* have been commonly used. One sample is dated July 1 1940, another January 4 1939. Judging by the history of ownership, these papers had been applied during the Gatenby's period of ownership (noting this may not necessarily correspond with occupancy as tenancy arrangements appear to have in place over certain periods – compare, for example, the information contained in section 3.0.1 of this report with section 3.0.2). Whichever the case, the dating suggests that Alfred Bye was not responsible for the application of the wall coverings nor the choice of theme. It is also reasonable to assume that he was not sufficiently bothered by it to want to change it to suit his own tastes. Alben Brazendale attests to Bye's work ethic, noting that Alfred routinely worked from dawn until well beyond dusk. Being a practical, hard working man, it may also have been the case that matters of interior decoration and taste were of little concern and peripheral to the business of running the property.

Photo 33: north east room, looking north with bed, and window.

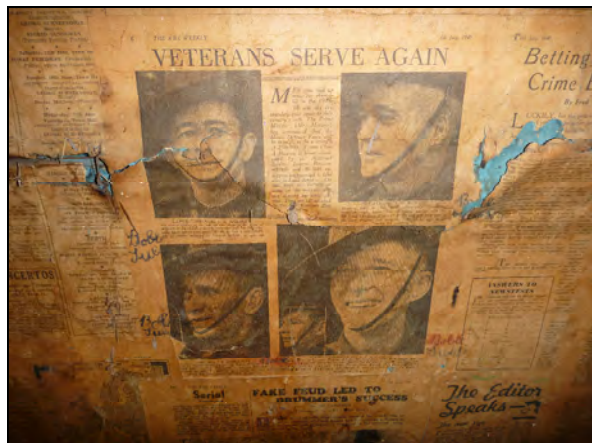
Photo 34: north east room, World War Two newspaper cutting.
